# Richmond Refinery LPS Bulletin – Safety

## Routine Maintenance Contractor Severed Fingertip

Rheniformer Plant Parking  
Area

Richmond Refinery

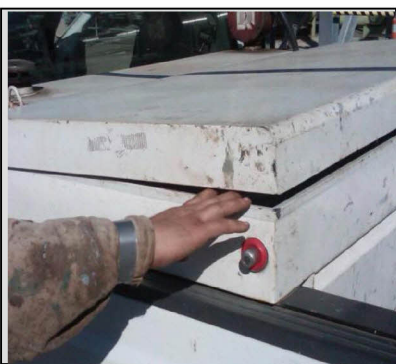
Toolbox lid was propped up for this reenactment

On October 31, 2011 at 1:12 p.m., a Redwood Painting Company employee sustained a significant hand injury. The tip of the ring finger of his right hand was pinched by the contractor's pick-up truck toolbox lid when another worker attempted to close the lid. As a result of this injury, the injured worker lost the tip of his right ring finger.

- 1) No verbal Loss Prevention Self Assessment (LPSA) was completed by the 2 contractor workers and the worker on the passenger side did not check that the line of fire was clear prior to shutting the tool box lid.
- 2) Current tool box cover shocks on the truck did not work. The shocks were 10 yrs old and evaluating tool boxes was not on the maintenance checklist used when performing maintenance on the truck. Shock failure was perceived as a minor and non-critical repair and they have had them fail in the past with no consequences.

- 1) RTD will be adding a check of the toolboxes and their shocks to their vehicle maintenance check list.
